Navajo Abandoned Uranium Mine

Site Screen Report

Plot 10 AUM Site

Navajo AUM Northern Region

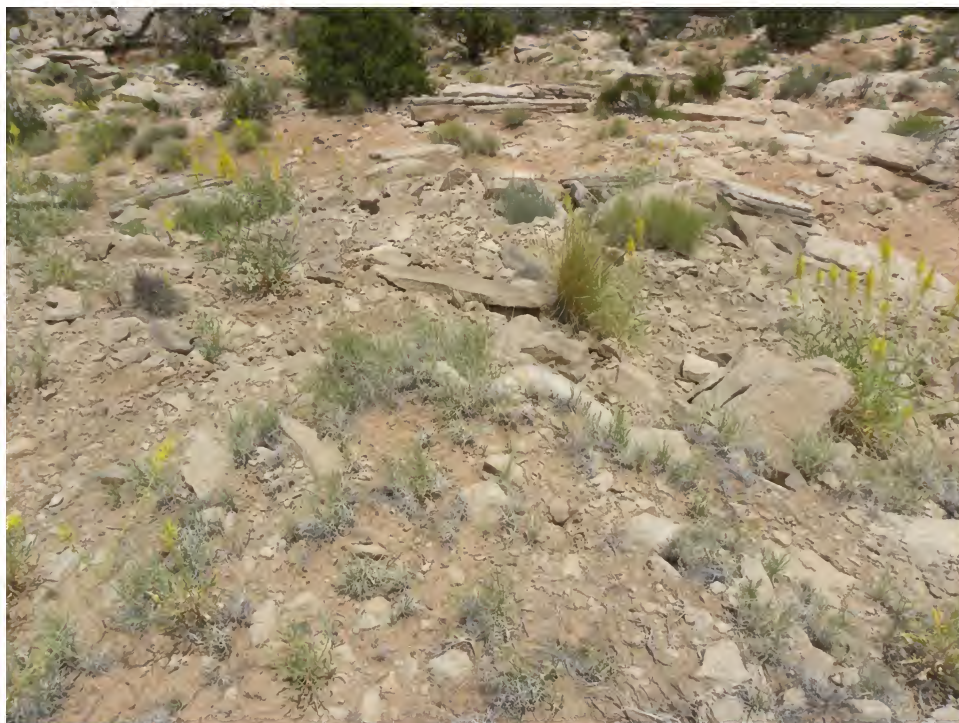
Photo 1. Plot 10 site

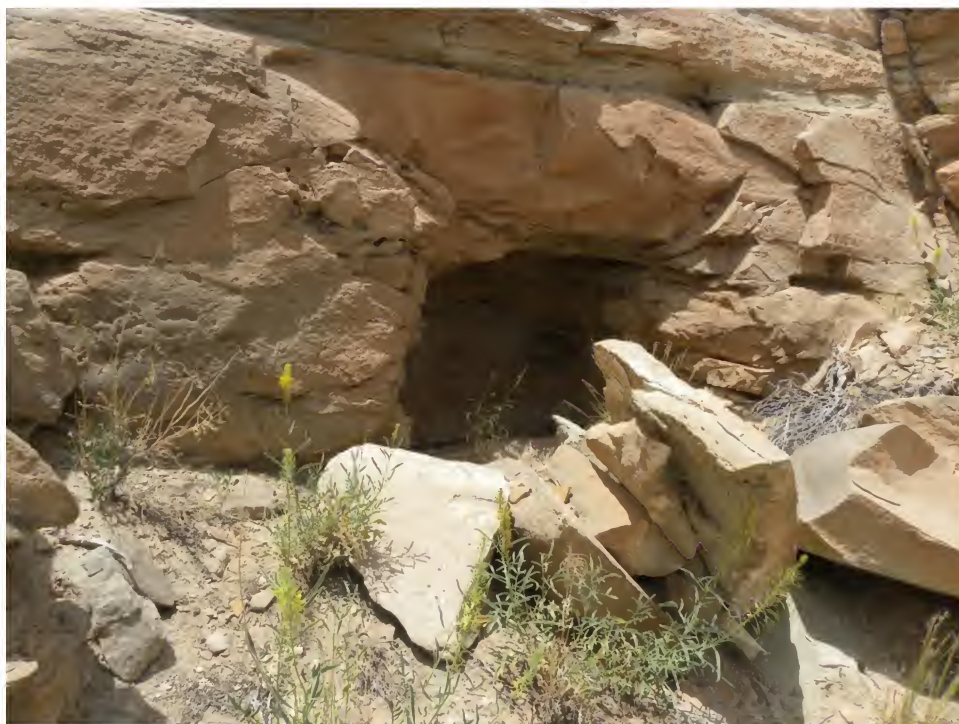
2 unfinished adits, 5'x5' & 4'x4'

Waste pile beneath adit 1 30'x20'x5'; waste pile beneath adit 2 15'x10'x3'

Photo 2. Plot 10 site, unfinished adit 1

2 unfinished adits, unreclaimed waste rock

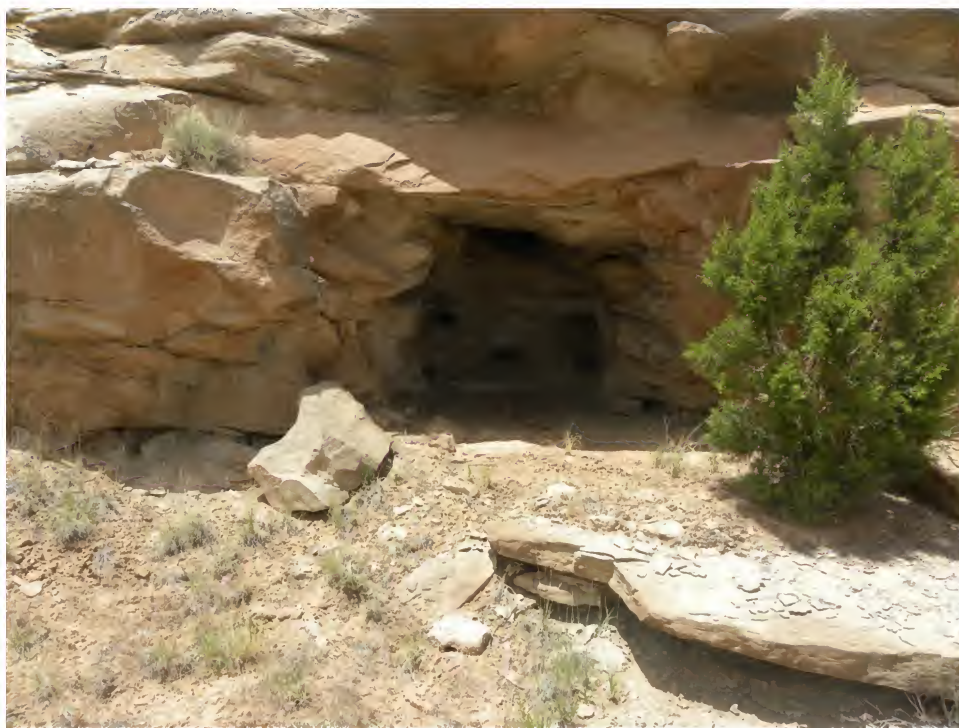
Photo 3. Plot 10 site, unfinished adit 2
